**TRAFFIC IMPACT STUDY
FOR
ATLANTA CHINESE CHRISTIAN CHURCH NORTH
JOHNS CREEK, GA**

**ACCCN
5055 Morton Road
Johns Creek, GA 30022**

A&R Engineering Inc.

August 28, 2015
A & R Project # 15-062

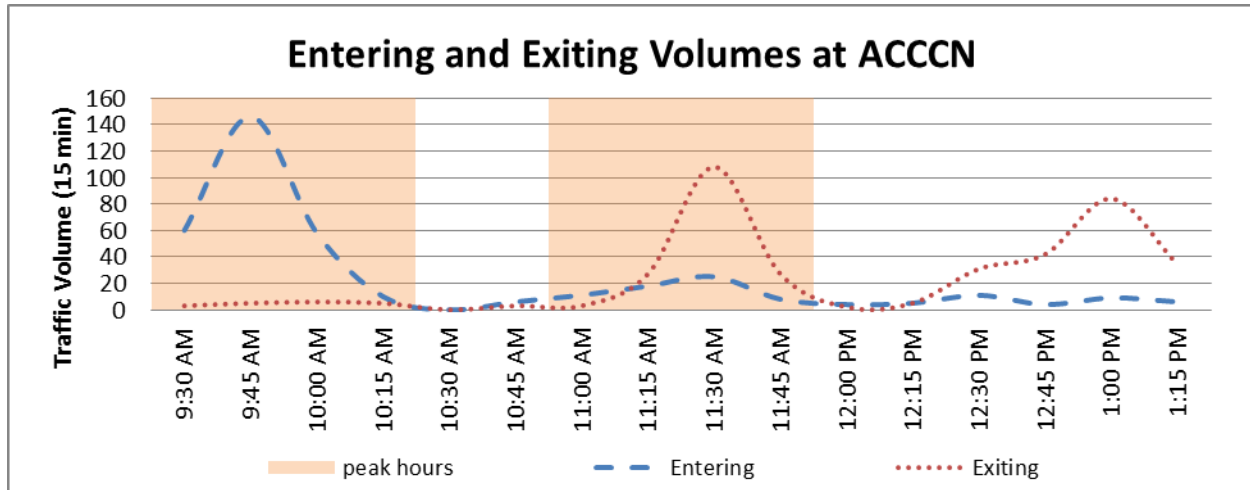
Figure 2 – Entering and Exiting Volumes at ACCCN Driveway

The four consecutive 15-minute interval volumes that summed to produce the highest volume at the intersections were then determined to be 9:30-10:30am for traffic entering ACCCN and 11:00am-12:00pm for traffic exiting ACCCN. These volumes make up the peak hour traffic volumes for the intersections counted and are shown in Figure 3.

Existing traffic counts and intersection geometric data were obtained for the E Morton Road at Plantation Drive / ACCCN Driveway intersection. Turning movement counts were collected on Sunday, August 23, 2015. All turning movement counts were recorded during the hours of 9:30am to 1:30pm. Data from the counts are shown graphically in Figure 2. Notably, the volumes on the ACCCN driveway indicate that there are two short periods of high-volume traffic with otherwise low-volume traffic during other times.

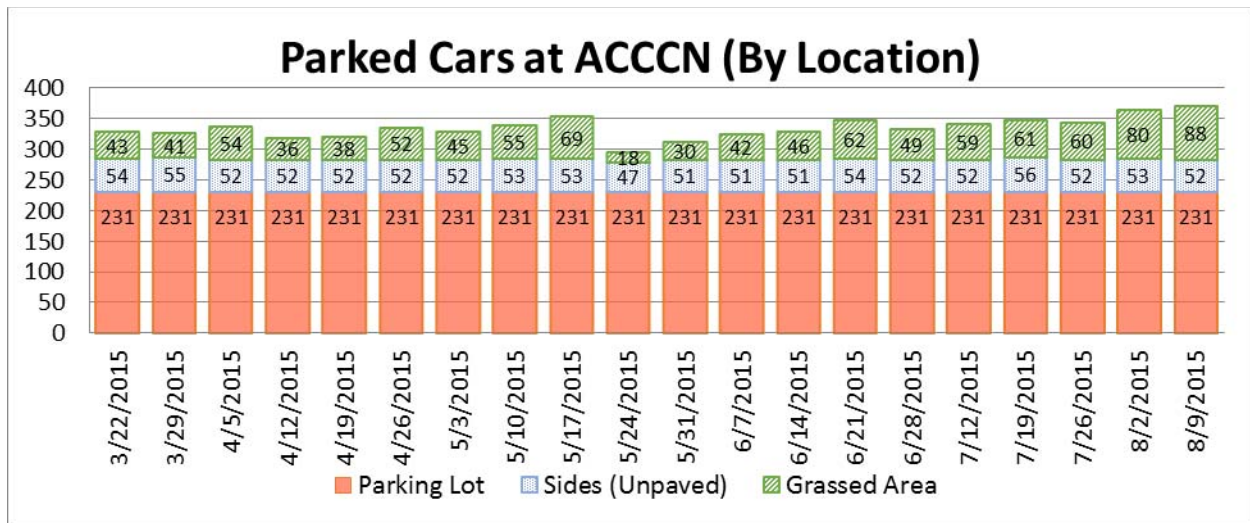
Figure 4 – Parked Cars at ACCCN

The current parking demand exceeds the number of paved parking spaces on the site. During each observed Sunday between March 2015 and August 2015, the paved parking spaces in the lot were 100% occupied, an average of 53 parked cars were observed in the unpaved spaces around the sides of the parking lot, and an average of 52 parked cars were observed in the grassed area. A chart for the number of parked vehicles by location is provided in Figure 4. The location of each of these areas is shown in Figure 5.

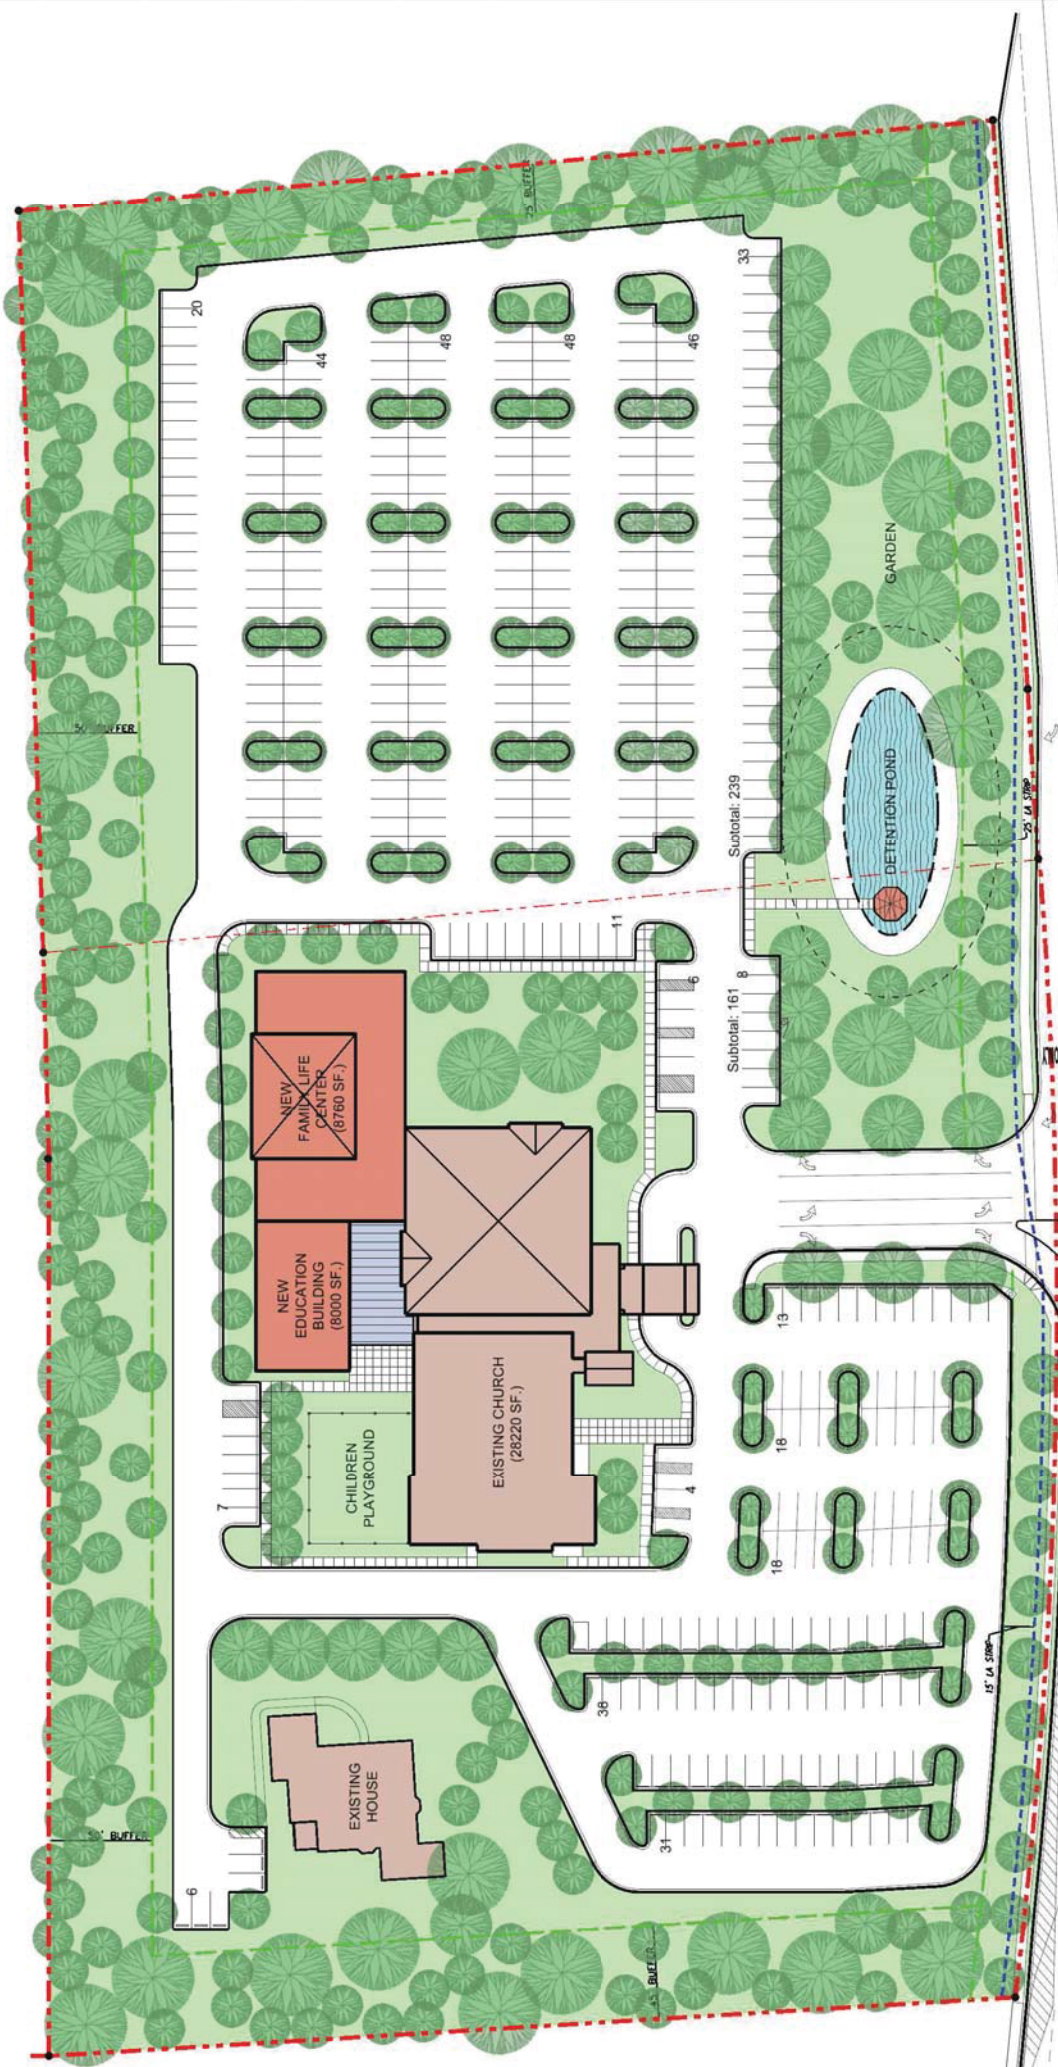
MASTER PLAN 2015 ATLANTA CHINESE CHRISTIAN CHURCH NORTH

EXISTING BUILDING : 28,220 SF.
NEW ADDITION: 16,760 SF.
TOTAL AREA: 44,980 SF.

TOTAL PARKING: 400 SPACES

It should be noted that the planned building addition will not affect the total seating capacity in the sanctuary, which will remain at 500 seats. A site plan is shown in Figure 6.

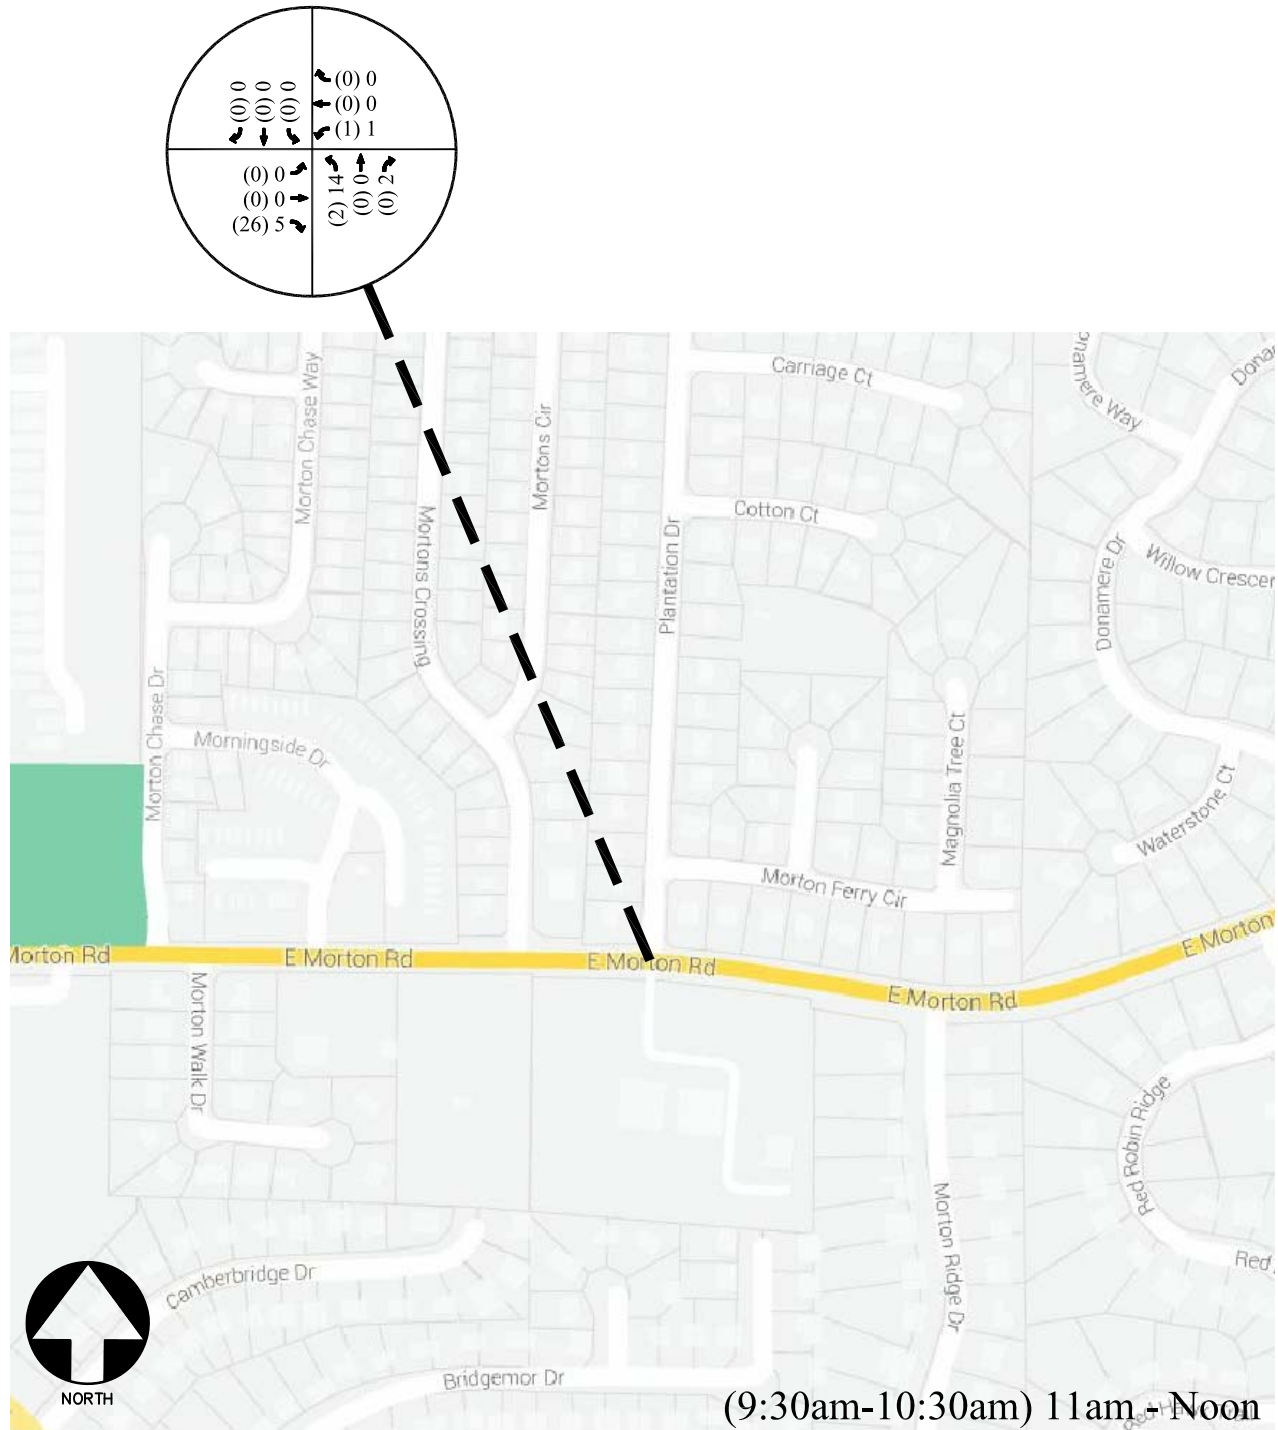
FIGURE 7
A&R Engineering Inc.

PEAK HOUR ADDED SITE TRAFFIC

The trip distribution describes how traffic arrives and departs from the site. An overall trip distribution was developed for the site based on the existing travel pattern. The site-generated peak hour traffic volumes, shown in Table 5, were assigned to the study area intersections based on this distribution. The peak hour new traffic generated by the site is shown in Figure 7.
